CENTRAL INTELLIGENCE AGENCY
INFORMATION REPORT

1. Our ship was in Fortaleza in February 1954 at which time we unloaded, among other things, heavy equipment for a power plant to be constructed in that area. I was able to make the following observations.

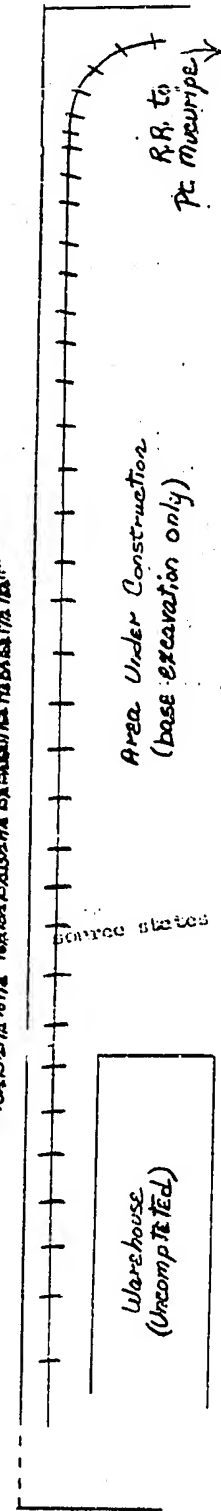
FORTALEZA, BRAZIL
Soundings Taken 2/1/54, reduced
To approximately level Mean
Low Water Springs.

- b. Pier and Dock Facilities: The pier at Mucuripe, shown on Hydrographic Office Chart #1163 running 211° to 031° , presently has a face 426 meters long. It is planned to eventually extend this pier to a length of 2,400 meters with a depth of 27 feet alongside. The pilot reports that the present depth February 1954 alongside is 18 feet. At present February 1954 only three ships can dock at a time. This makes it necessary for 70 per cent of the ships using the port to anchor about 500 yards from shore and discharge cargo into lighters. There are seven cranes on the pier, but they can only lift up to 10 tons. A ship has to use her own cranes to discharge any heavy lifts. There is a small gauge railroad track about six feet from the edge of the pier. During our visit, railroad cars were pushed by hand when empty and by truck when loaded. As is shown on figure (1), there is one uncompleted warehouse on the pier.

- h. Repair Facilities: There are sufficient facilities for most repairs not requiring a drydock.
- i. Soundings made at Dockside: The soundings shown on figure (1) show very little water on the inside of the vessel. However, I definitely recall these soundings were taken from the wharf and that the bank no doubt falls away steeply to the outer soundings.
